**Flood Control Project Maintenance  
Levee Inspections**

**2010 Channel Summary Report**

**San Joaquin County Flood Control and Water Conservation District**

**Flood Control Project Maintenance****Unit Cover Sheet****2010 Channel Inspection Results****San Joaquin County Flood Control and Water Conservation District**

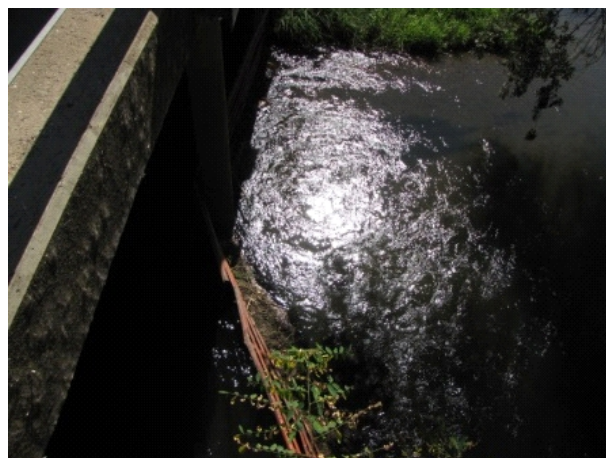
Levee Mile Report Line	15
Start Levee Mile	0.00
End Levee Mile	0.00
Location	
Category	Channels
Item	Encroachments
View of the cattle gate in the channel bottom under the downstream side of the Sonora Road bridge.	
dpesaven_c_20100824_007.jpg

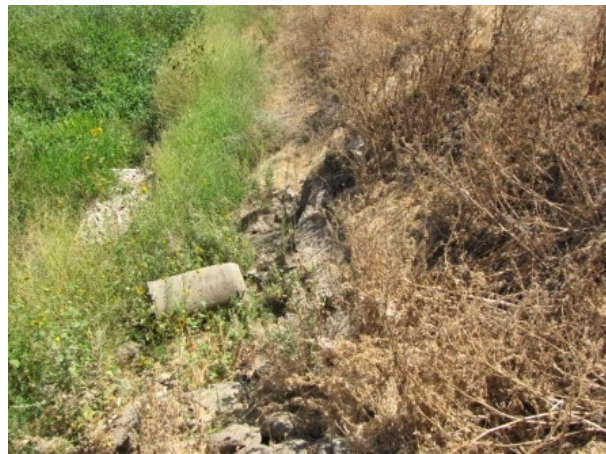
Levee Mile Report Line	58
Start Levee Mile	0.00
End Levee Mile	0.00
Location	
Category	Channels
Item	Erosion / Bank Caving
View of minor erosion occurring under a culvert cutting into the channel toe on the upstream side of the Jack Tone Road Bridge. While this erosion will not prevent the channel from functioning as designed, the erosion should be evaluated.	
dpesaven_c_20100824_031.jpg
